## Engine

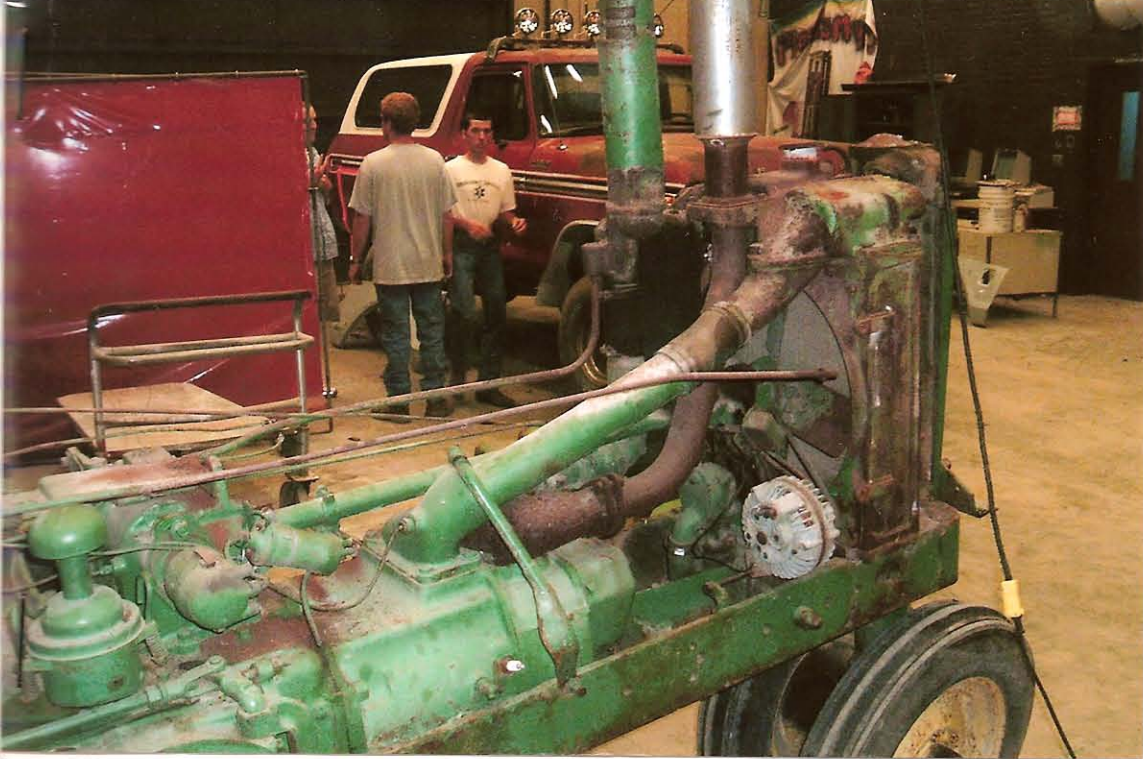
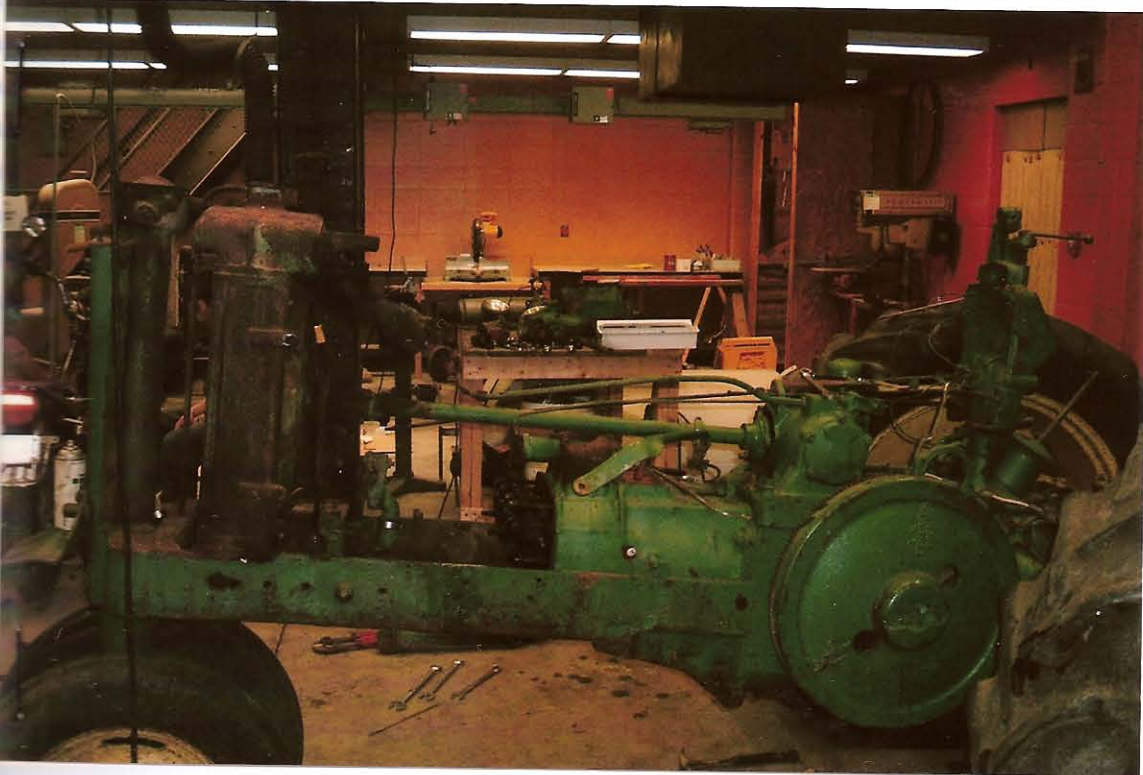
1

The engine did not run, and after disassembly, we realized was totally shot. The original block was cracked the entire length of the block on the bottom side of one of the cylinders. Another block was located at Dennis Polk Equipment from New Paris Indiana and was machined by Woody's Machine Shop in Thorntown Indiana. The block that we acquired, which was the only block for that tractor that Polk's had at that time, was bored to 0.045' over with some pretty severe surface rust. It turned out that it had to be bored to 0.125" over to clean up and some new pistons were acquired from Polk's. Woody's machine also ground the valves and seats and surfaced the head, as well as checking the crankshaft for round. The engine was reassembled with now main bearings, all new gaskets from Jackson-Lee-Pearson John Deere in Frankfort, Indiana, and the new pistons and rings from Polk's. The camshaft and camshaft bearings as well as the governor system all checked out and needed no major repairs. The Manifold was abrasive blasted and coated with high temperature paint and the mounting studs were replaced. All of the engine work was done ourselves except for the machine work that was done by Woody's machine. We would like to give a special thanks to all three businesses that helped us with the engine. Jackson-Lee-Pearson supplied all parts that we acquired through them at cost. Dennis Polk and Associates gave us a 20% discount on all parts, and Woody's machine gave us a 25% discount on labor. We would also like to thank Buis oil of Noblesville, IN for giving us a discount on the Chevron SAE 30 oil that was used in the tractor. The biggest challenge of the engine was the shimming of the rod and main bearings and getting everything timed to specifications.

Pictures one and two engine before disassembly.

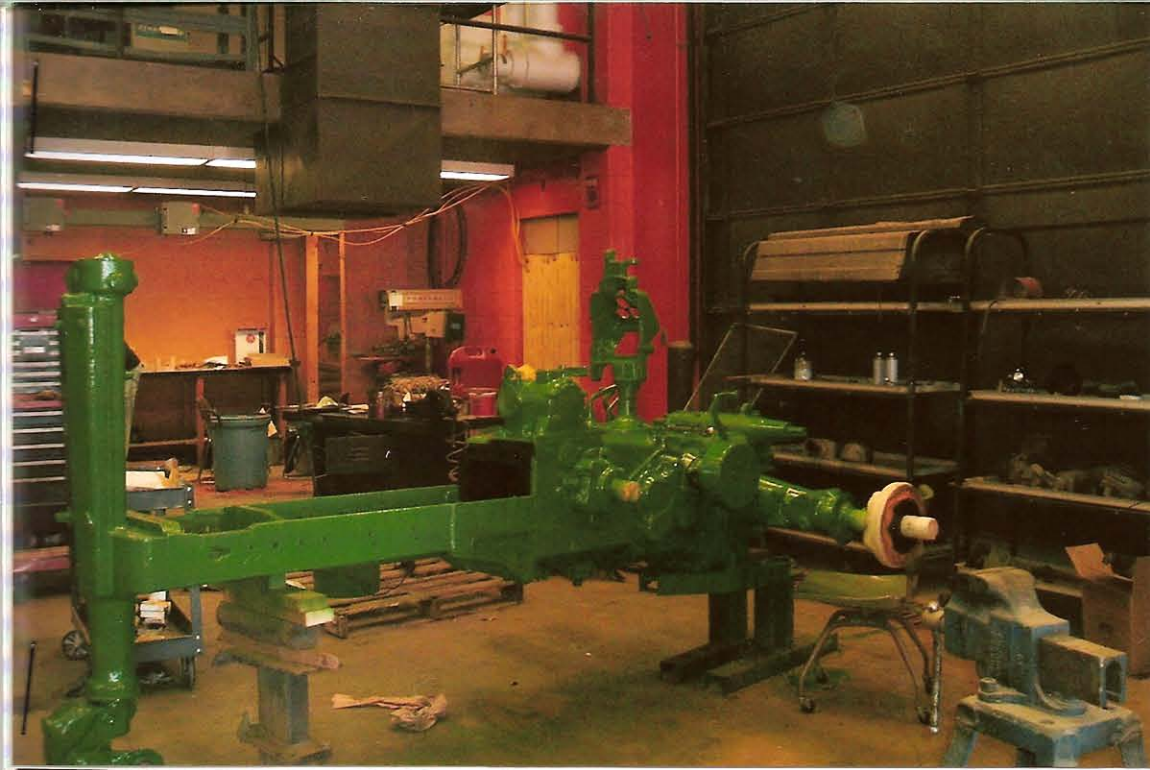
3

Picture three is engine after crankshaft installation before block installation and picture four is the installation of the bottom radiator hose mounting.

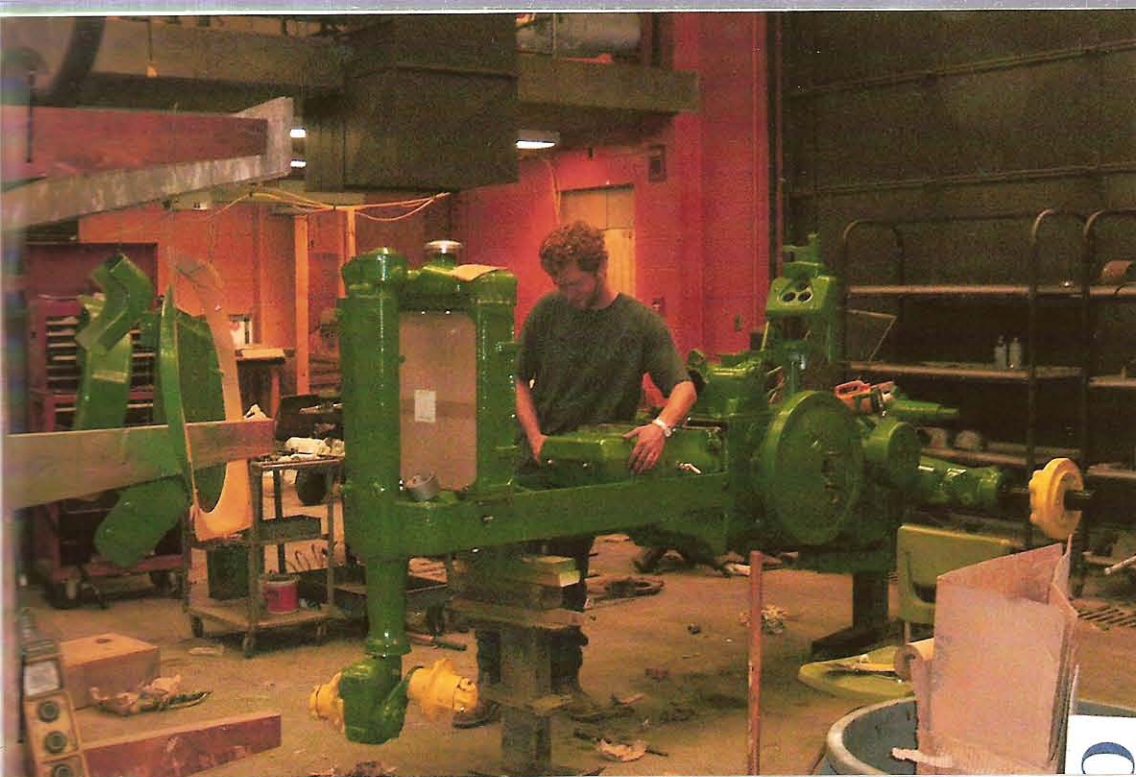
5

Picture five is the installation of the valve cover and picture six is the finished engine.
