Final Drive

restoration competition

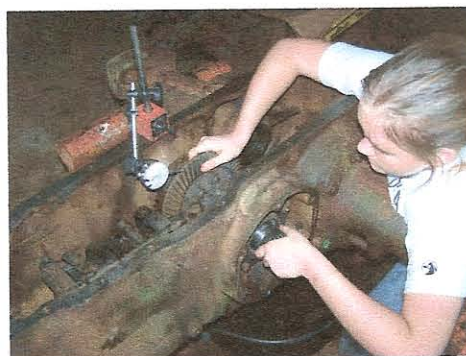
The final drive consists of the bull gears, ring gear, and the two rear axles. When I was working in the transmission I had taken out the bull gears, cleaned them, and turned them around so it could run on a new wear surface. Once back in, I had to check the backlash on the ring gear with a dial indicator.

After cleaning out the rear axles I had to replace the seals in them. To do this and have the housing seal properly, the housing was held slightly off the rear end. Then I installed seals in the end of the axle housing. After sand blasting was complete I filled the housing with gear oil.
