Delo[®]

Tractor

restoration competition

Safety Report

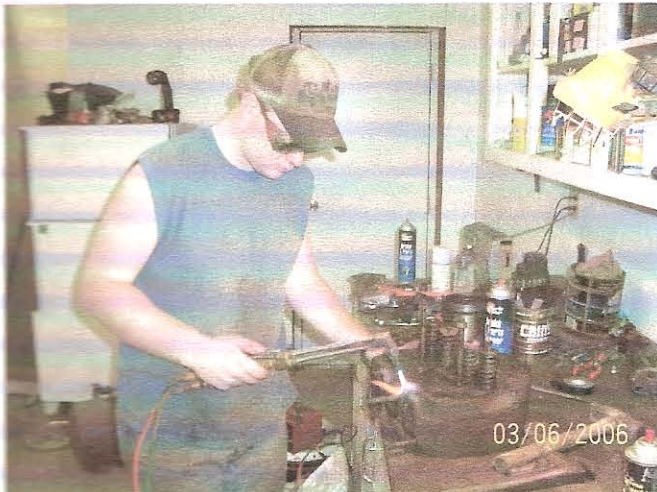
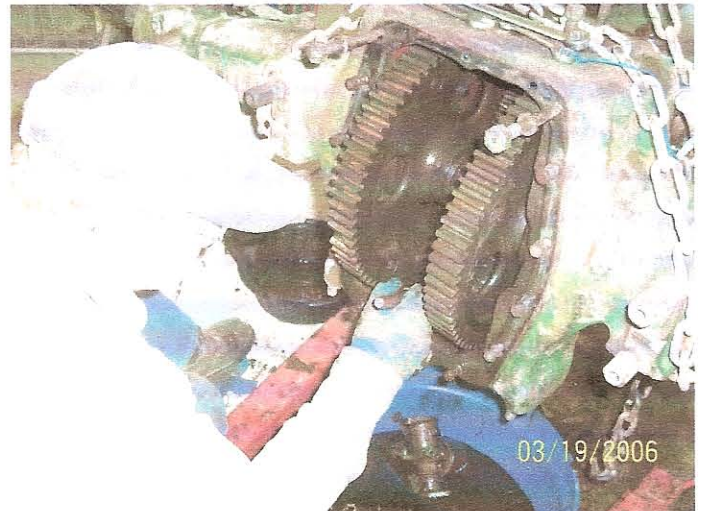
- I always wore safety glasses.
- I wore shaded glasses when using the torch.
- I wore chemical resistant plastic gloves when working with solvents.

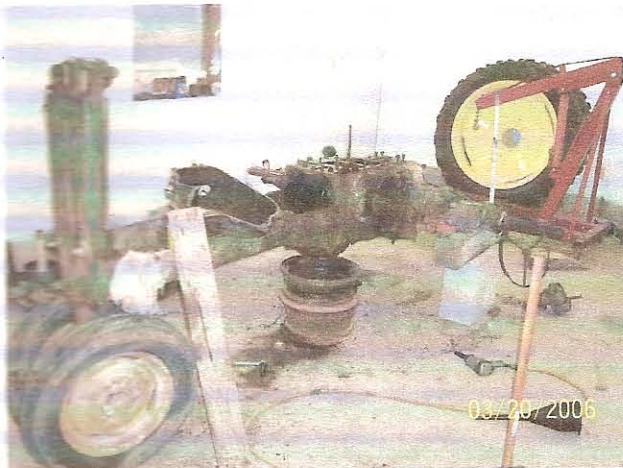
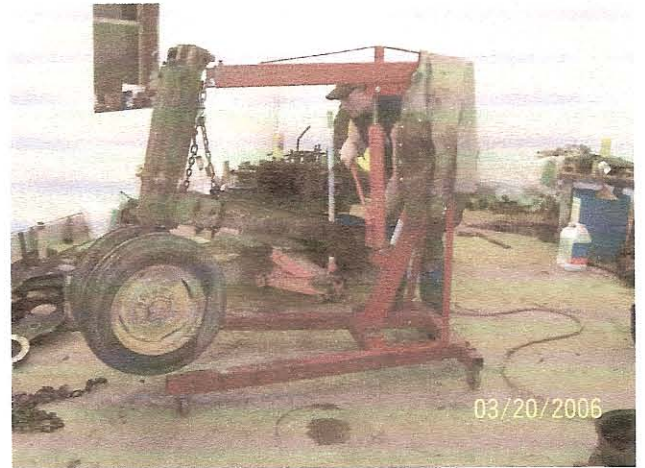
- I always blocked up the rear axle while working on it to make sure it didn't tip over
- I picked up all heavy parts either with the cherry picker or our bobcat.
- I wore the proper protective gear while sandblasting.
- I removed all the flammable solvents from the room when I was welding or using the torch.
- I always wore a canister respirator, long sleeves and latex gloves while painting.
- I also set up an exhaust fan in the window to remove as many fumes as possible from the room while I was painting.

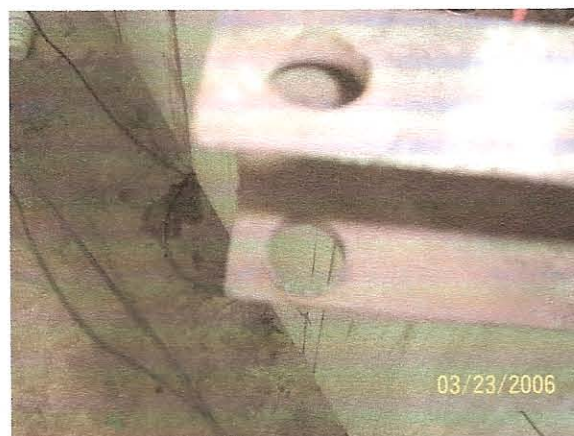
- The seat pin hole was worn where all the pressure is exerted. I built up the hole and drilled it out again and put a new pin in. I paid special attention to this area because I have heard several stories about when the pin broke, the hole wore too thin and broke or something in the seat broke and the operator was killed or hurt severely when his implement ran over him.

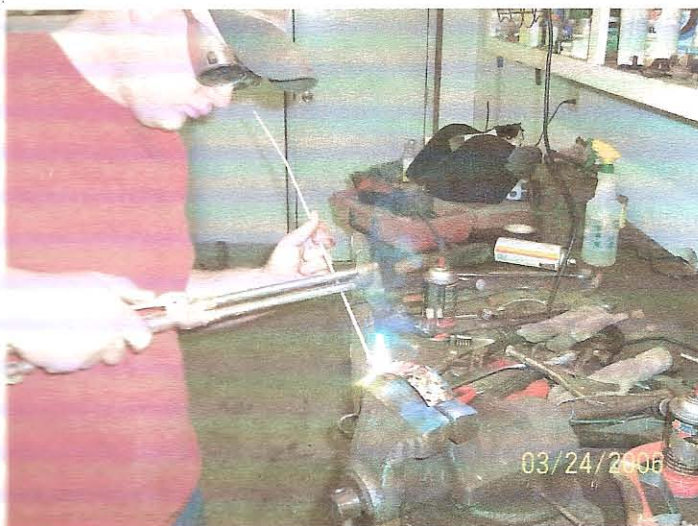
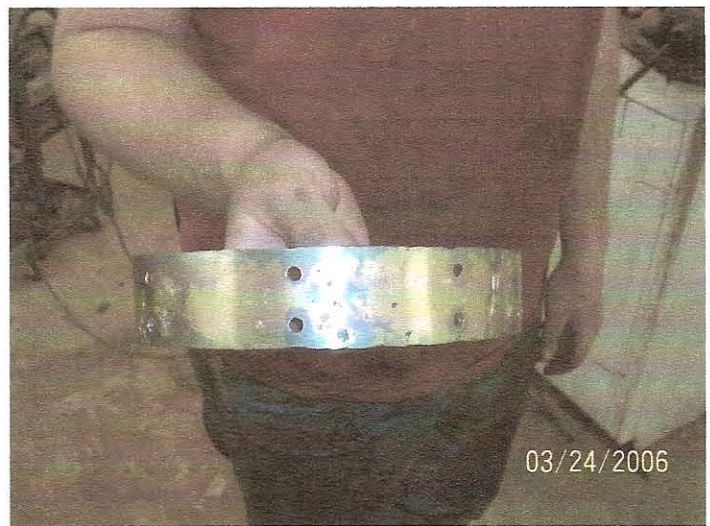
- I put new brake pads on and repaired some brake shoes.

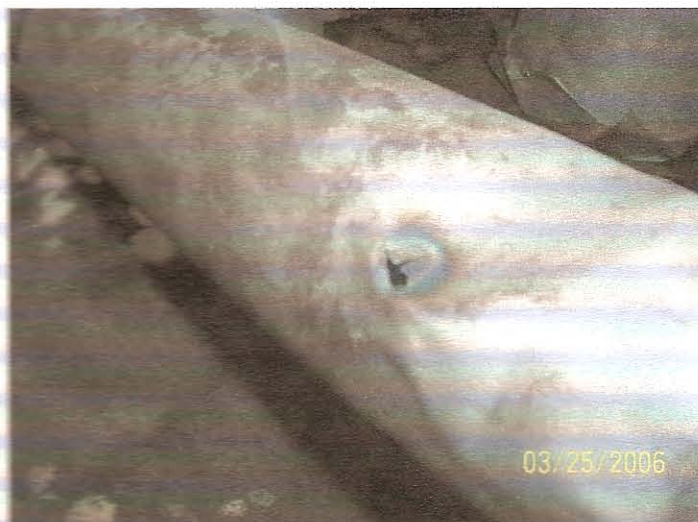
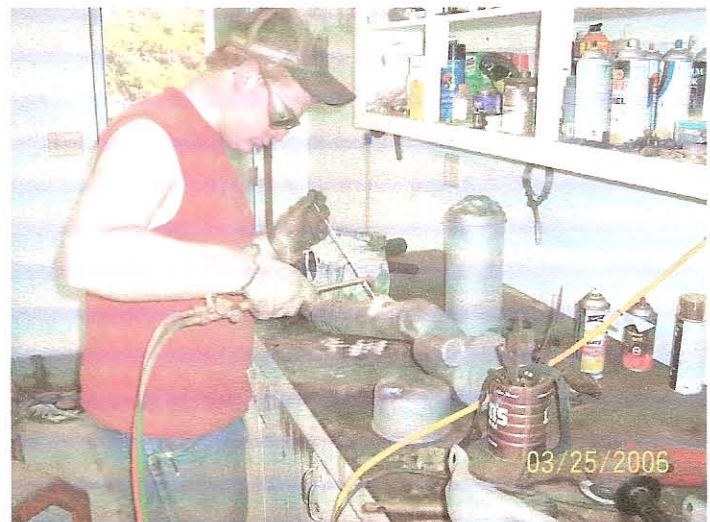
- I repaired the steering wheel shaft where it was worn.
- I put a bushing in the clutch handle.
- I patched a hole in the air intake breather.
